THE ARCHITECTURE OF PUEBLO BONITO

NEIL M. JUDD

CITY OF WASHINGTON
PUBLISHED BY THE SMITHSONIAN INSTITUTION
JUNE 30, 1964

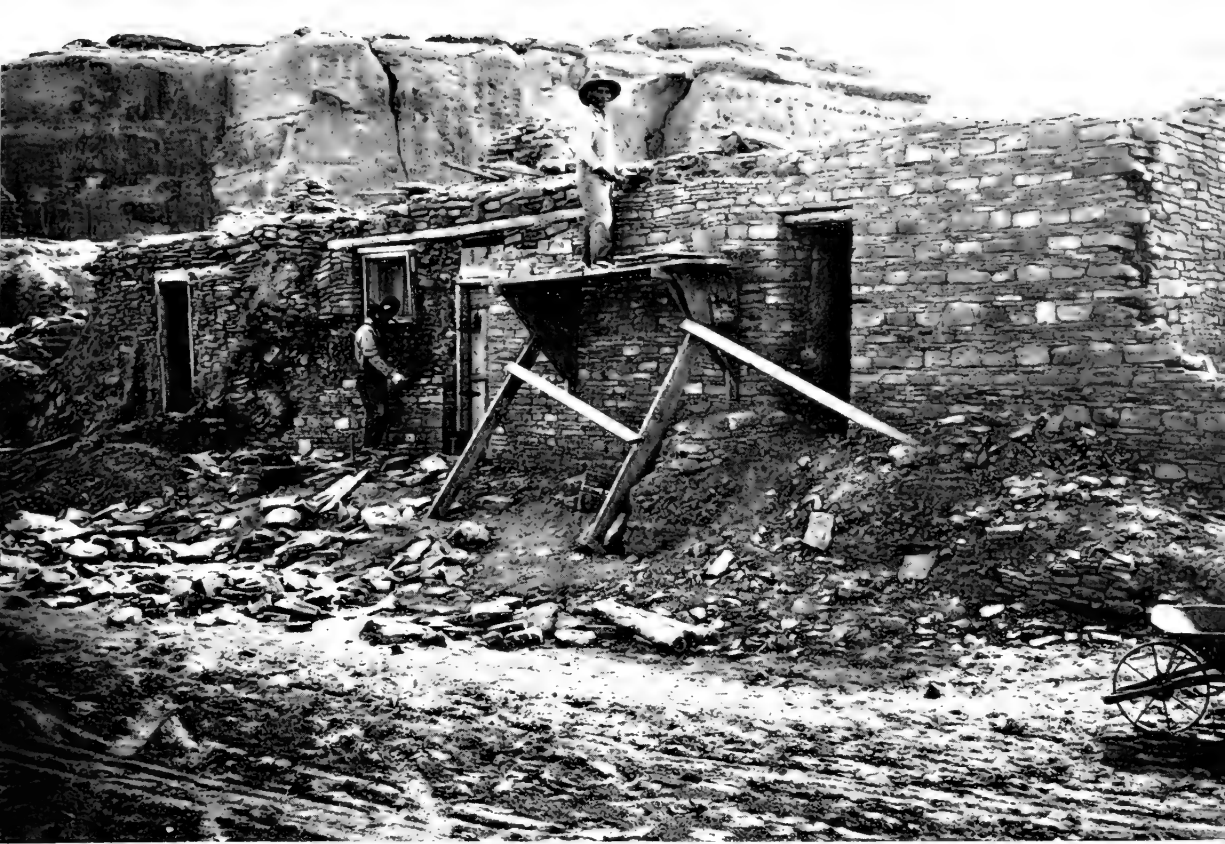
PLATE 4

Upper: Rooms 122-124, rebuilt by Richard Wetherill, were repaired by the Pueblo Bonito Expedition for laboratory use.

Lower: An apparently unfinished wall in the southwest corner, East Court, overlay older structures. Above, the exterior of Rooms 150-152 with ancient repairs.

were revamped and reroofed for occupancy. These same rooms were later utilized by the School of American Research (Hewett, 1921, p. 12), and they were still habitable when we repaired them for laboratory use in 1925 (pl. 4, upper).

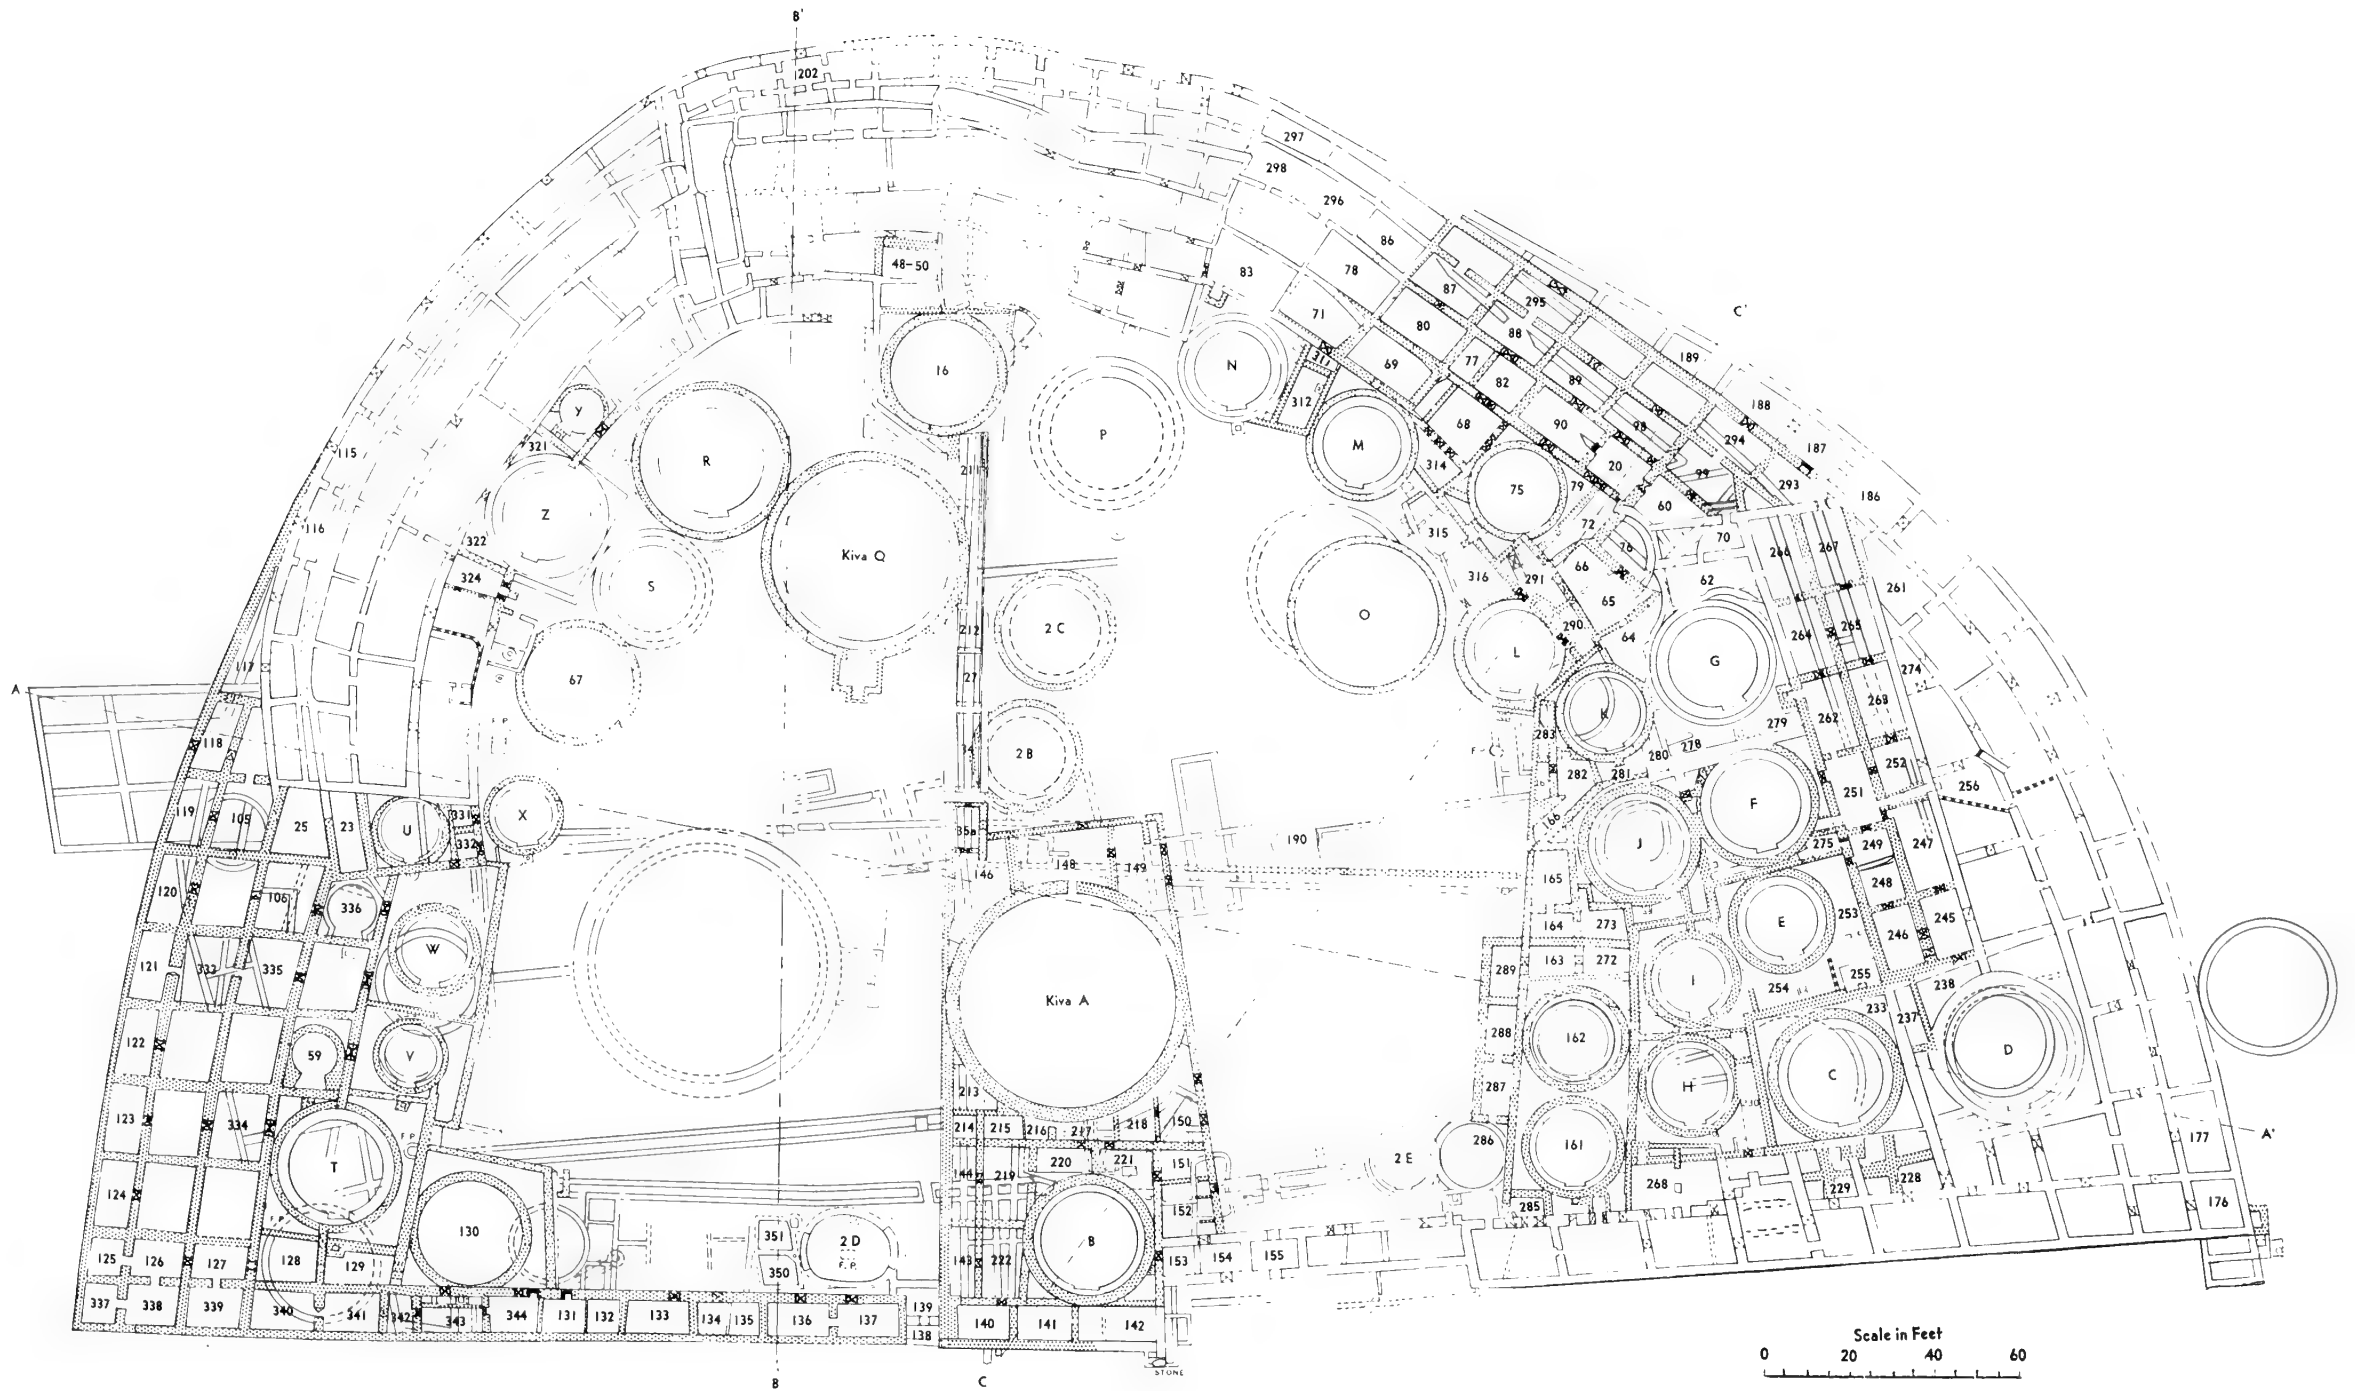
FIG. 5.—Ground plan showing extent of the second Late Bonitian addition with known subfloor walls and foundations for third-type masonry.

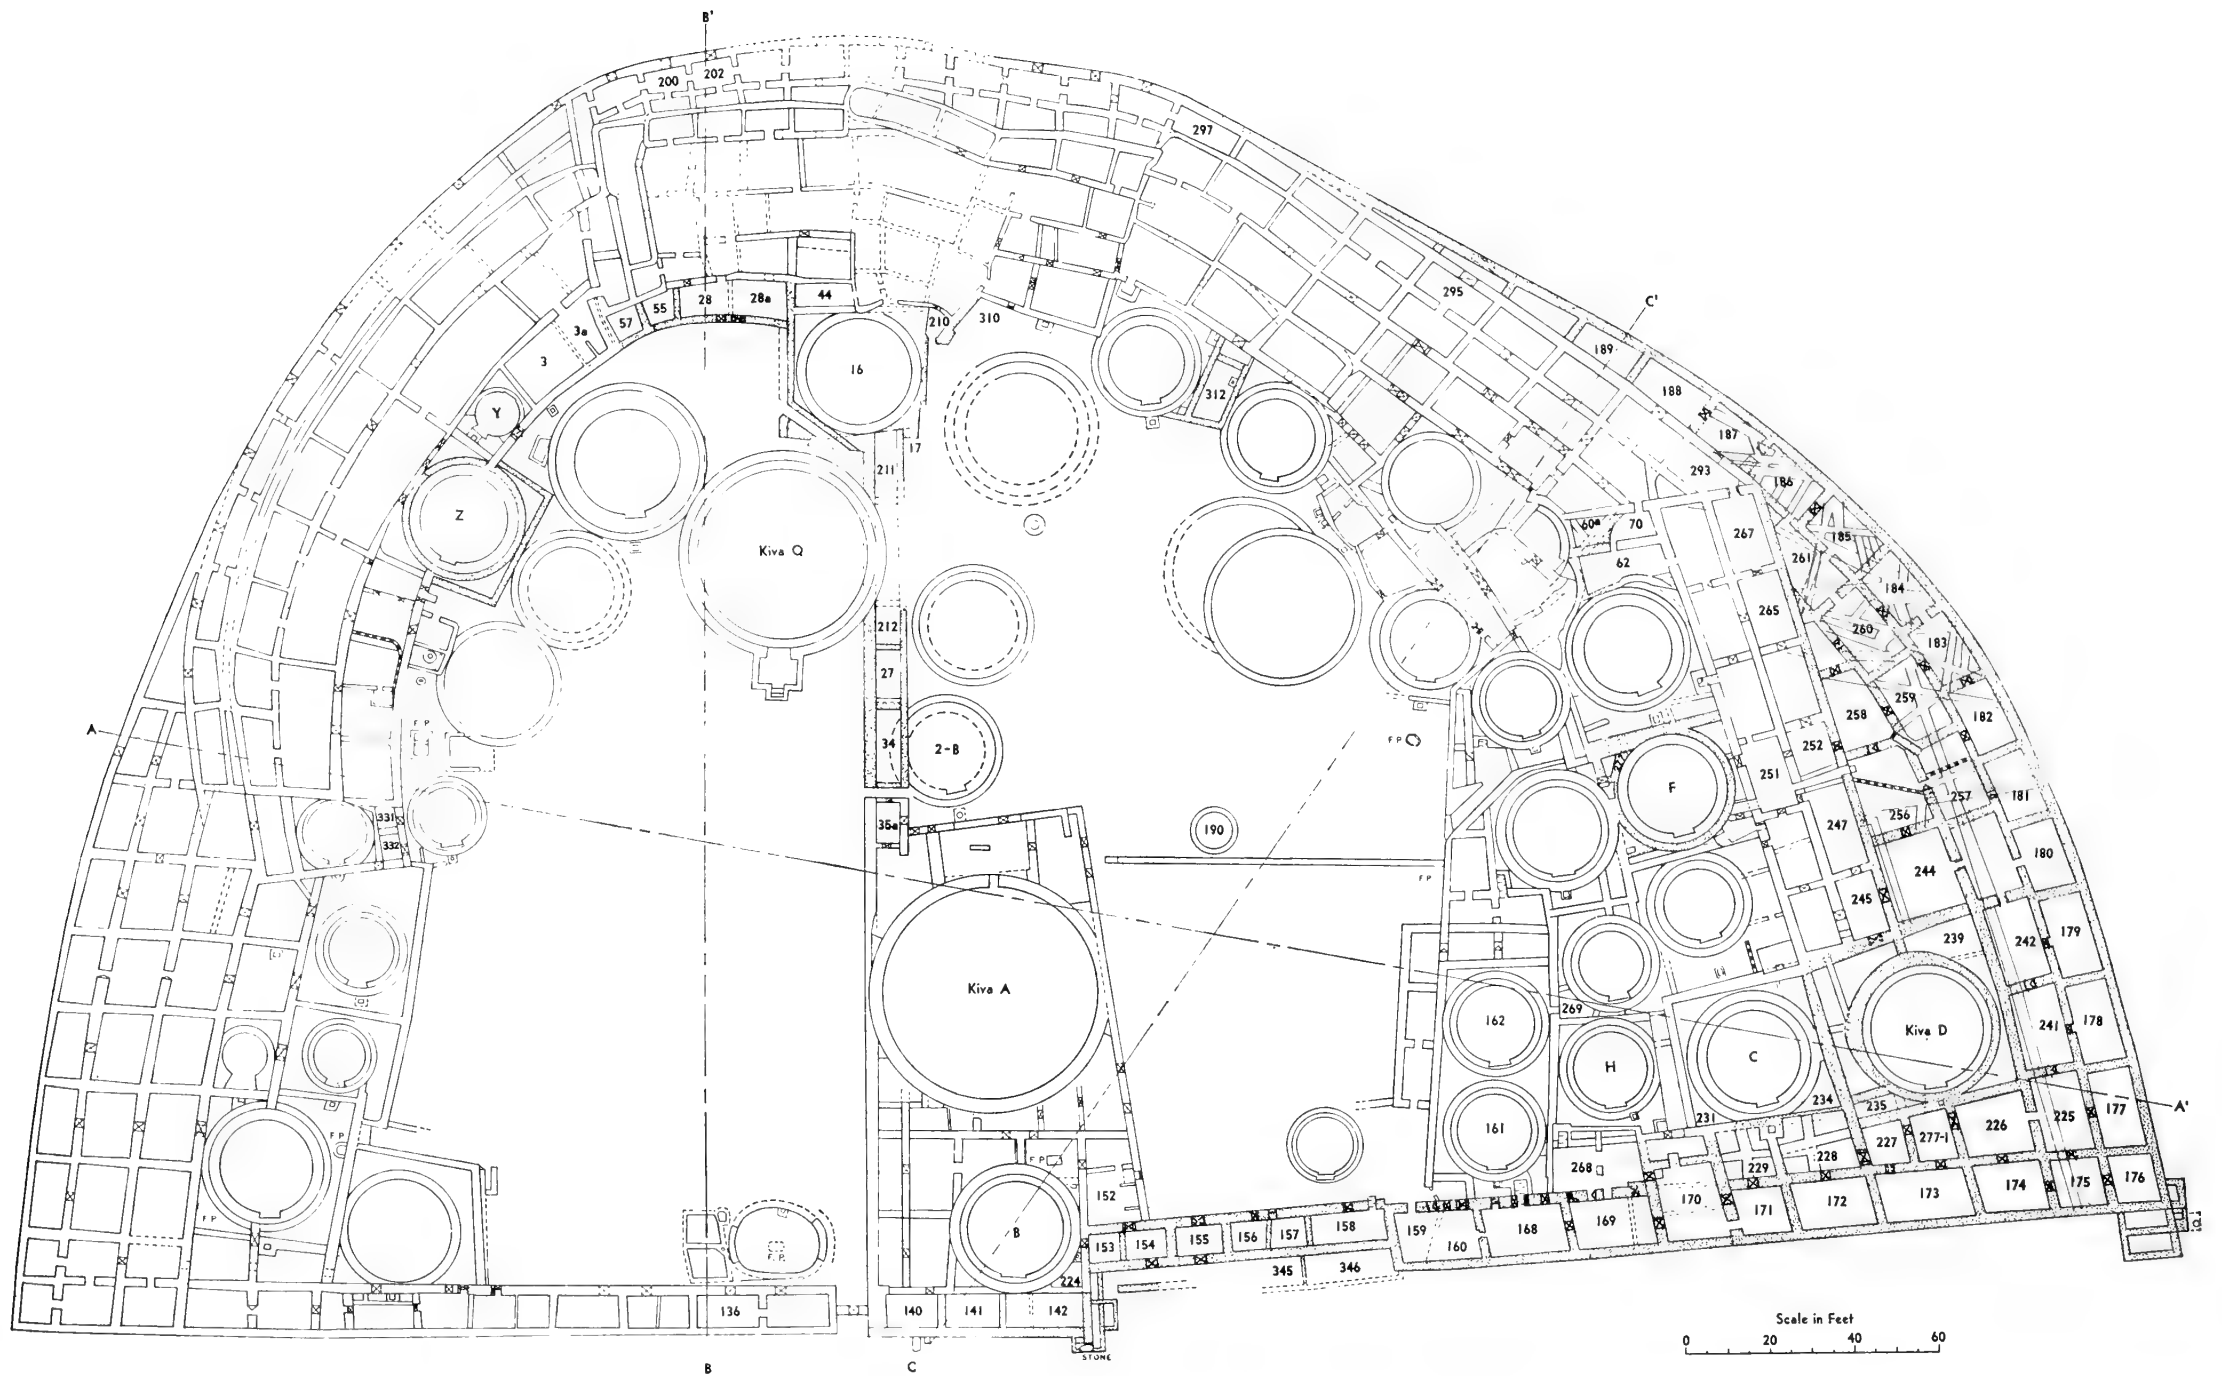
FIG. 6.—Ground plan showing final additions to Pueblo Bonito and known subfloor foundations for fourth-type masonry.

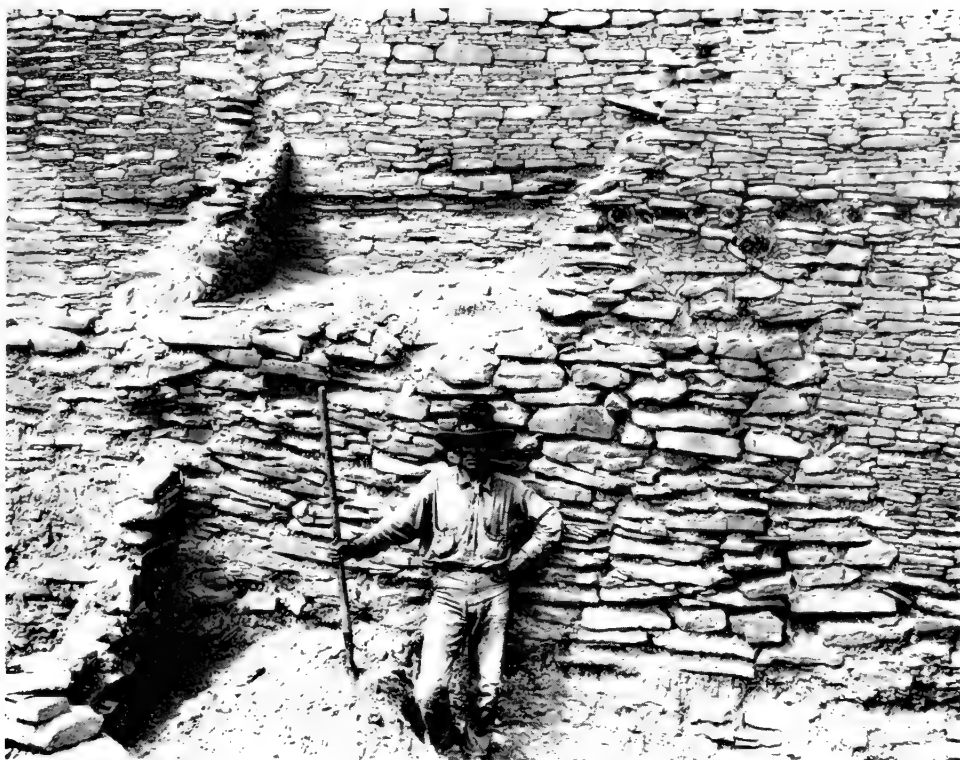
Third-type replacement of first-type masonry, north wall of Room 86B. Second-type interior, room north of 296B, at upper left.

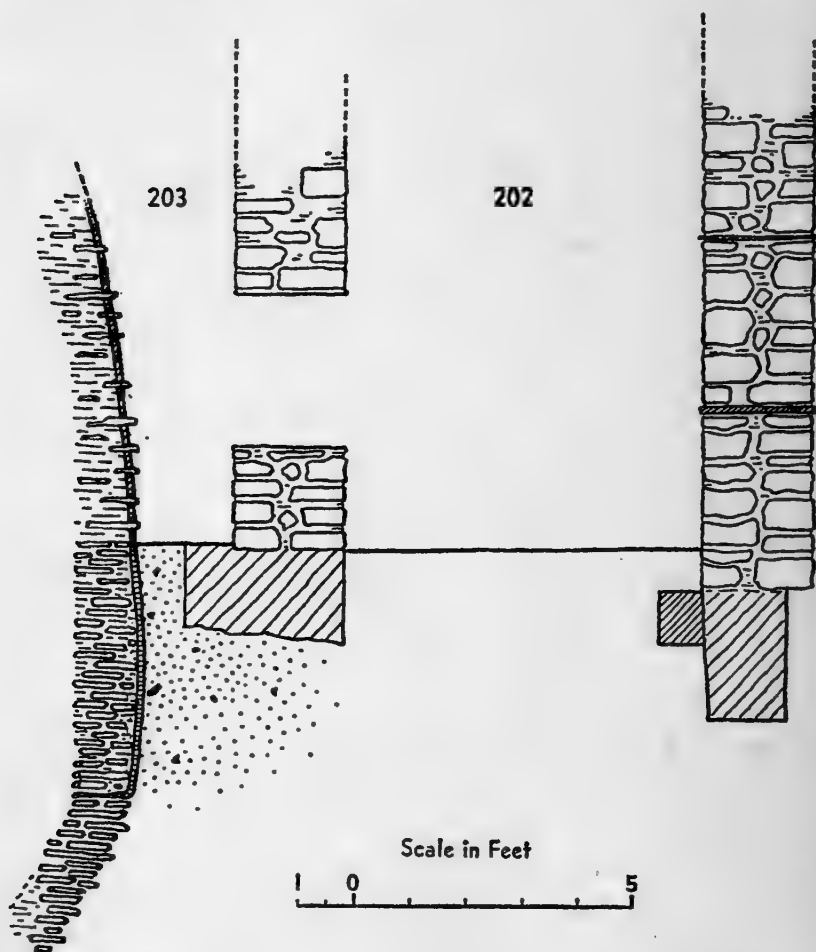
FIG. 10.—Diagrammatic sketch showing relationship of Late Bonitian Rooms 202-203 to Old Bonitian Rooms 4-5.

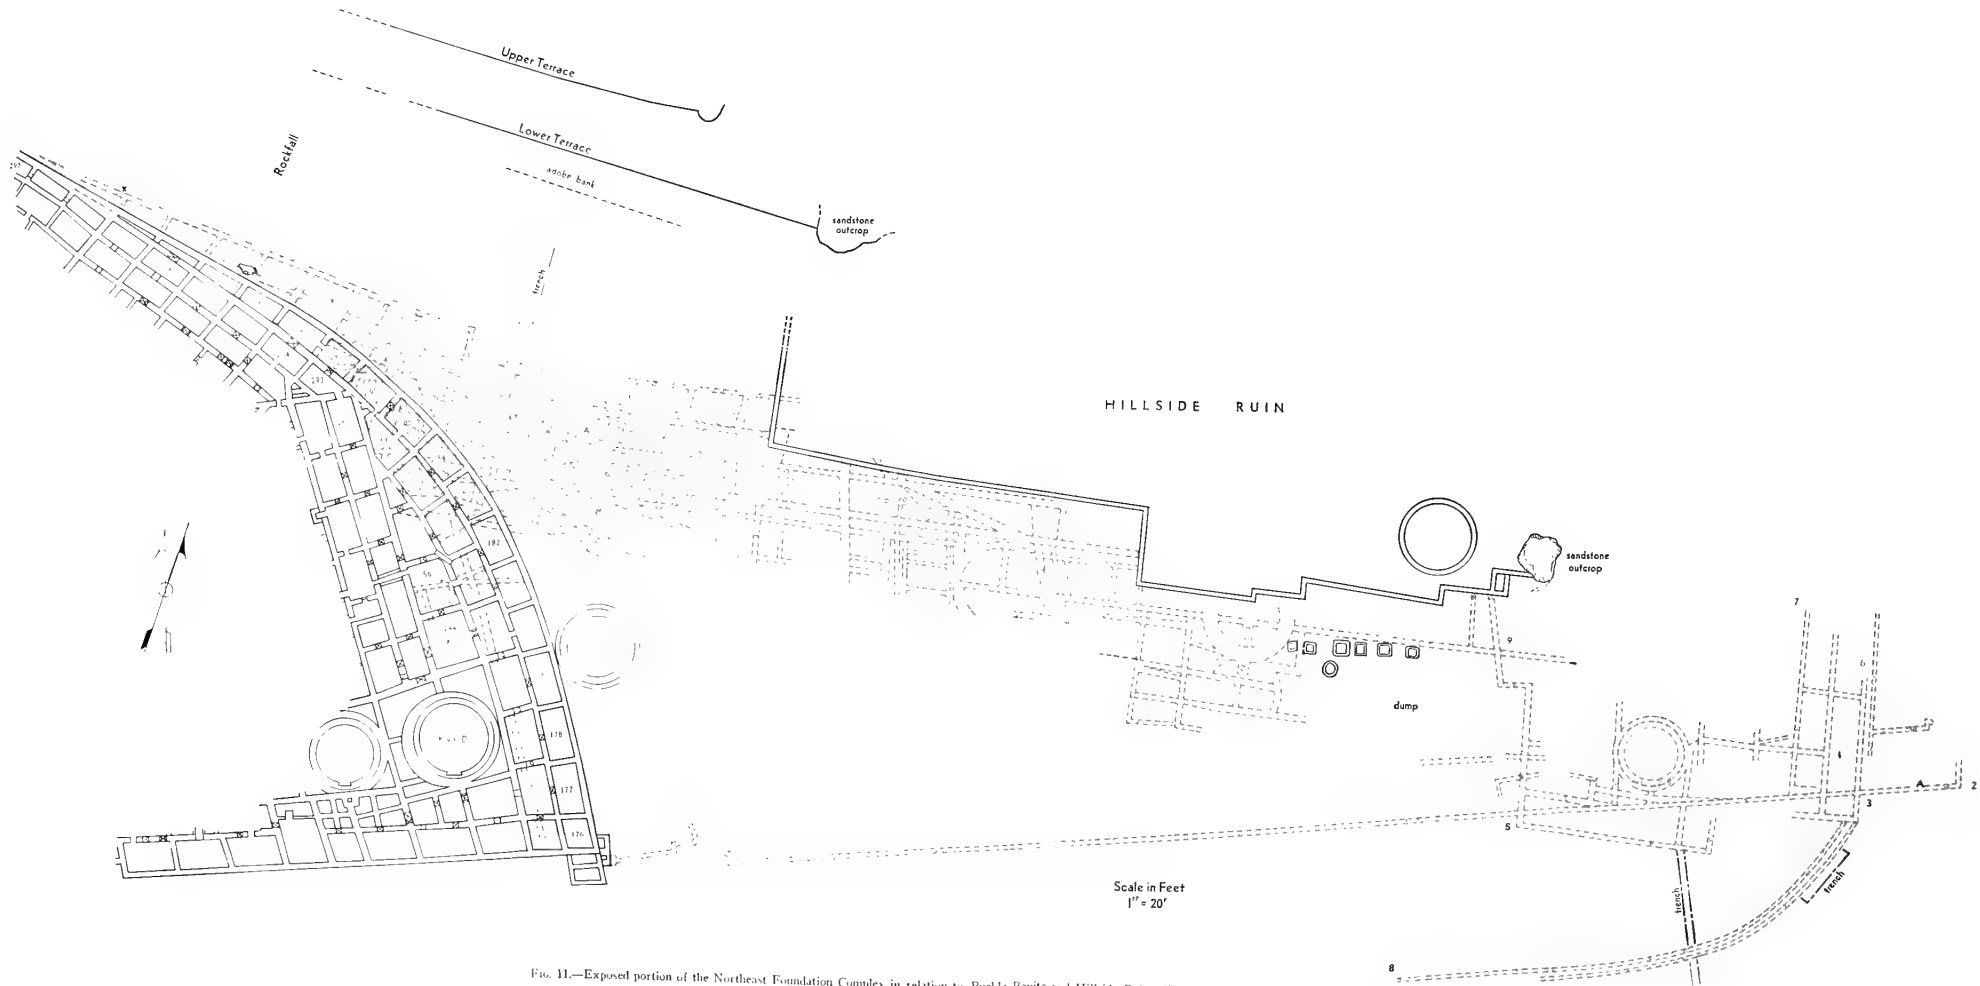
FIG. 11.—Exposed portion of the Northeast Foundation Complex in relation to Pueblo Bonito and Hillside Ruin (From the original survey of Oscar B. Walsh.)

Figure 11 shows only that portion of the Northeast Foundation Complex we actually uncovered. We have no knowledge of what still lies buried. A cross section (D-46) between "A," on a main east-west foundation outside Room 185, and a like symbol near Station 2 at the east end of our trenching operations does not, in my opinion, contribute enough information to justify its reproduction herein. It remains on file at the U. S. National Museum together with all other diagrams and field notes of the Pueblo Bonito Expeditions. I might add, however, that 12 deep silt layers shown on that cross section lie at practically the same level, no more than 8 inches apart vertically.

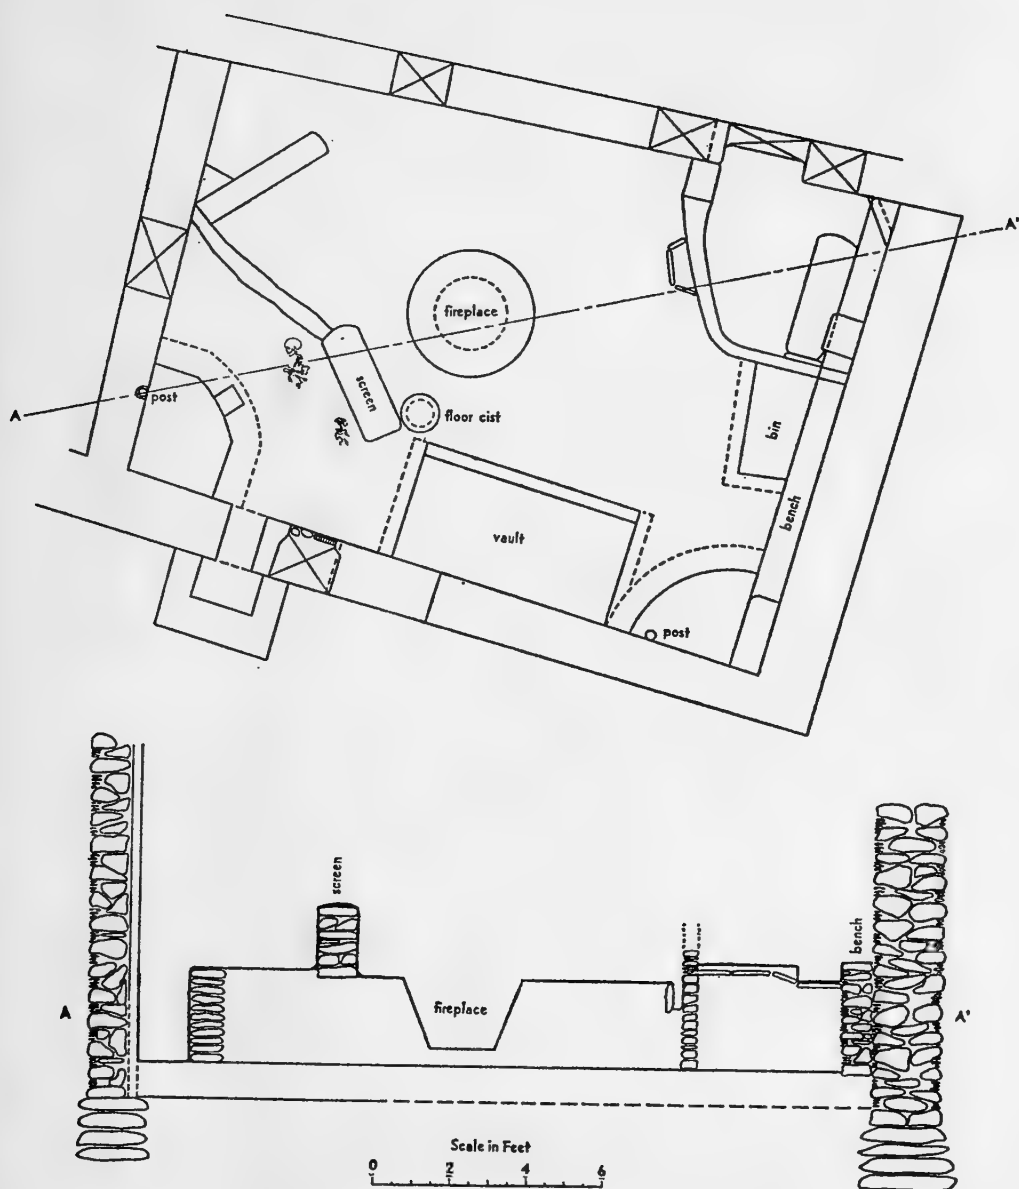
FIG. 12.—Late Bonitian Room 309 and cross section.

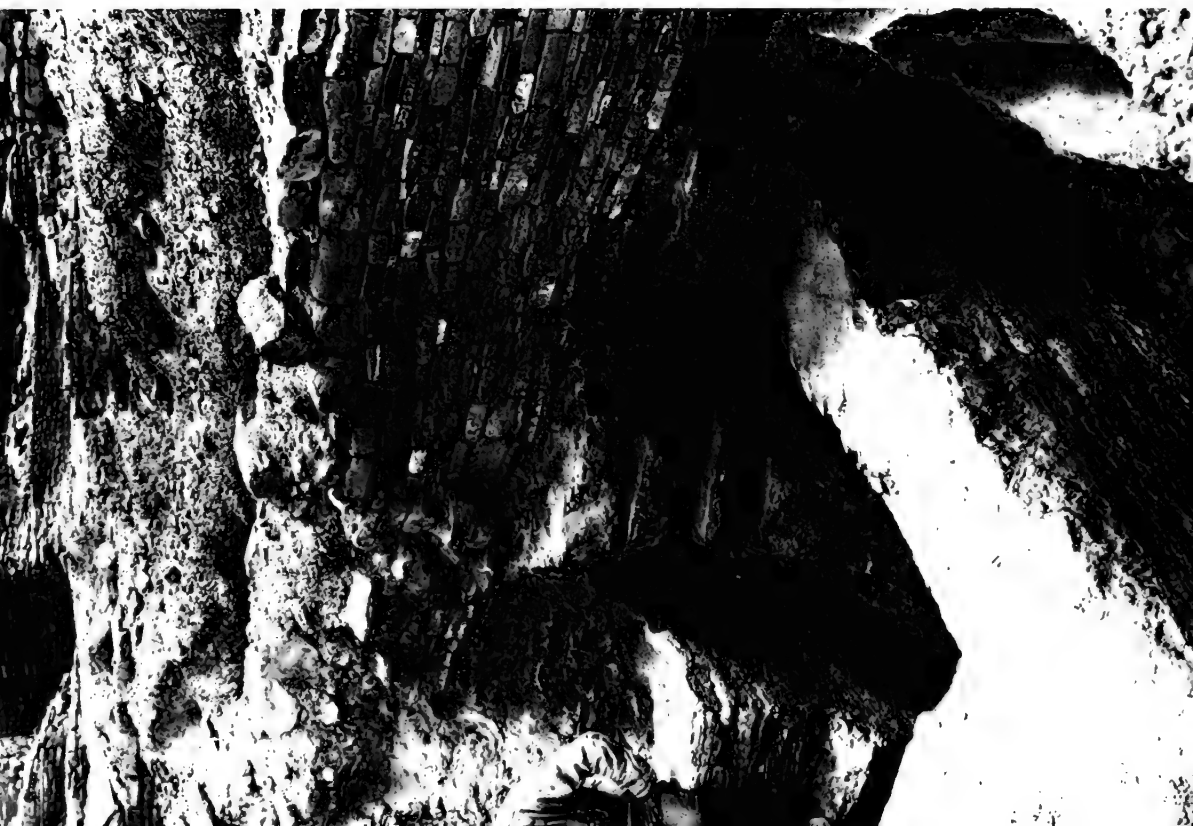
PLATE 33

Left: The outer west side of Room 167, repaired, overlaid partially razed second-type walls continuing across the East Court.

from under Room 167 and continuing westward (pl. 33, left). About 5 feet from its point of emergence that wall was joined by another that diverged somewhat from the line of 167 to form a small room 4 feet 3 inches wide. Despite its narrowness, this small room had been a dwelling. Its three visible walls were plastered and the plaster rounded to its floor, 6 feet below the surface. Part of a T-shaped door survived on the north side, its sill at a height of 17 inches; beneath it was an adobe step 6 inches high, its front sloping from a 9-inch base to a 7-inch tread.

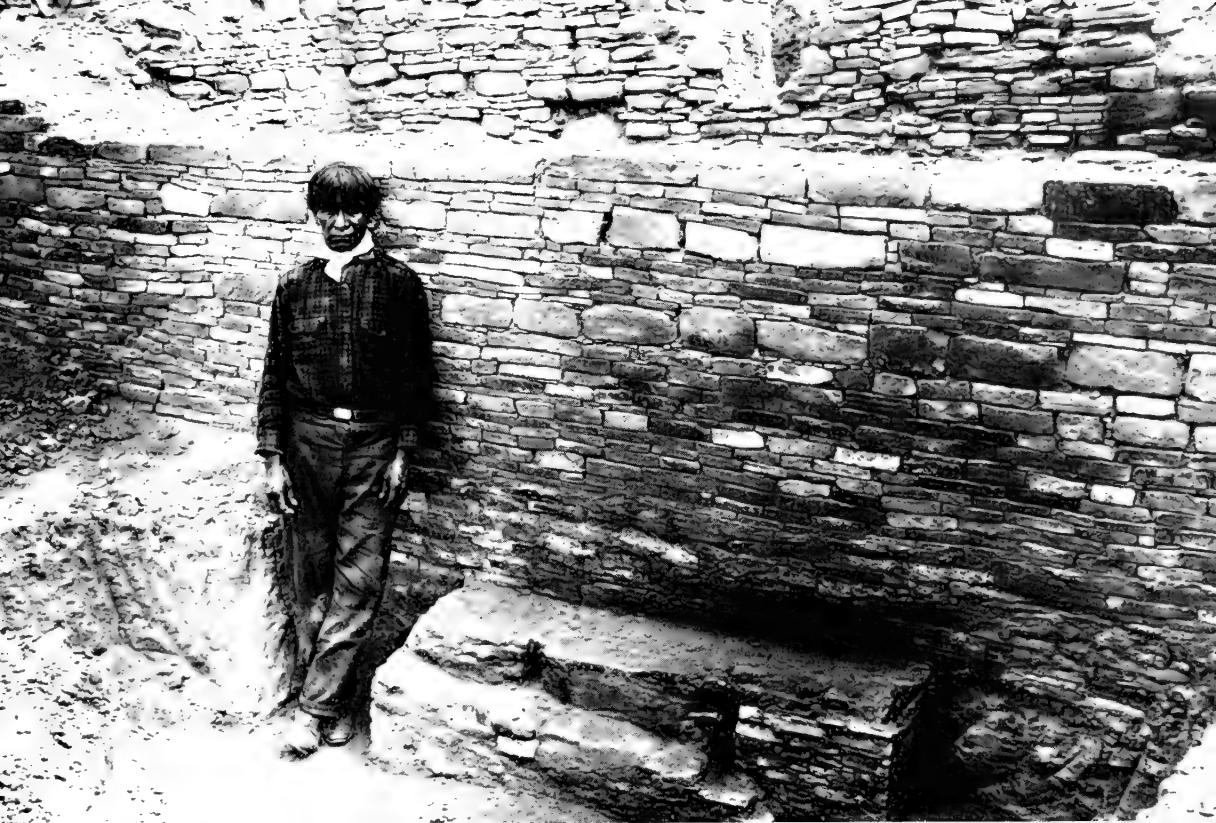
PLATE 36

Lower: Paired second-type-masonry walls were partially razed at a height of $2\frac{1}{2}$ feet to support a later wall that underlies the west side of Room 146, above.
(Photograph by Neil M. Judd, 1926.)

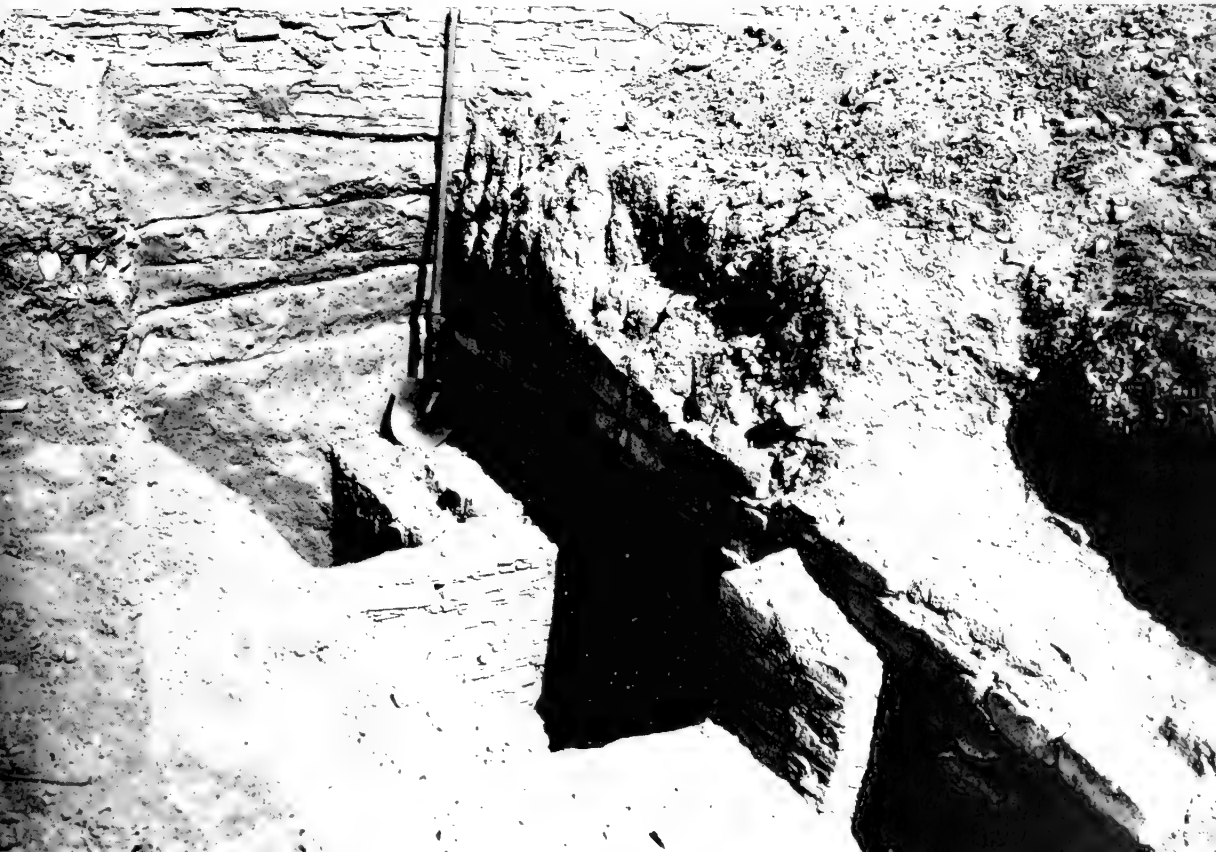
PLATE 37

Lower: In the east wall of Room 117 third-type masonry replaces the original second-type, removed for an intended 6-room addition.
(Photograph by O. C. Havens, 1925.)

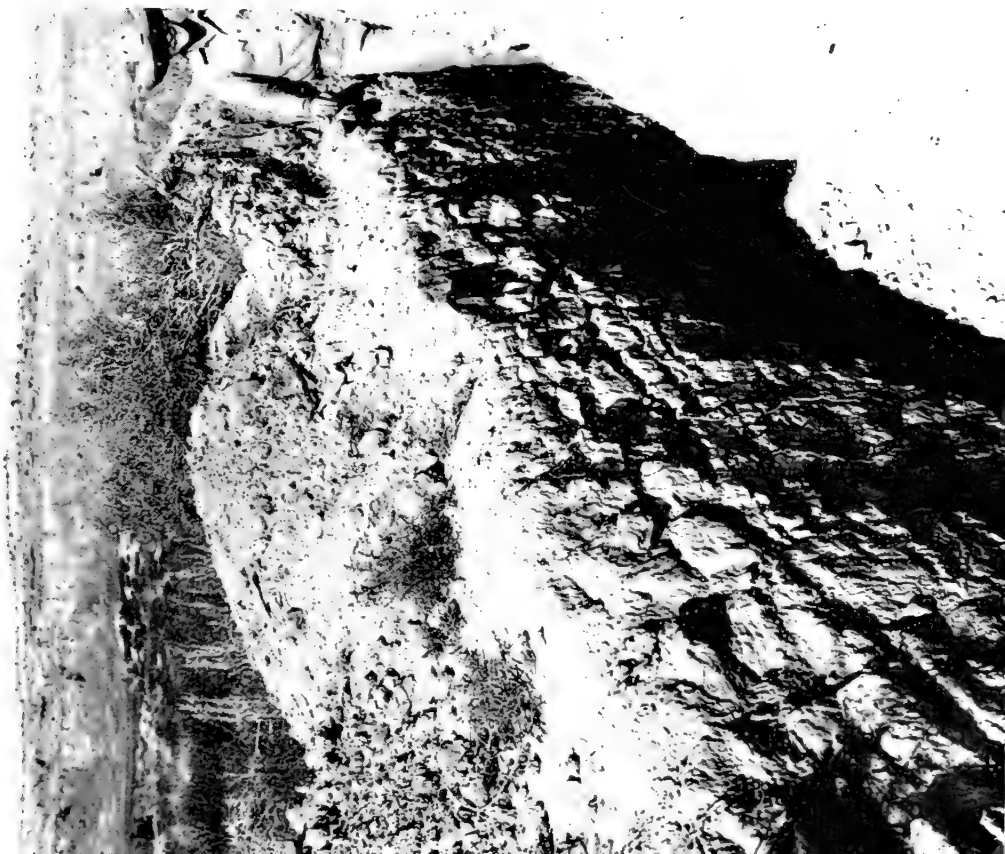
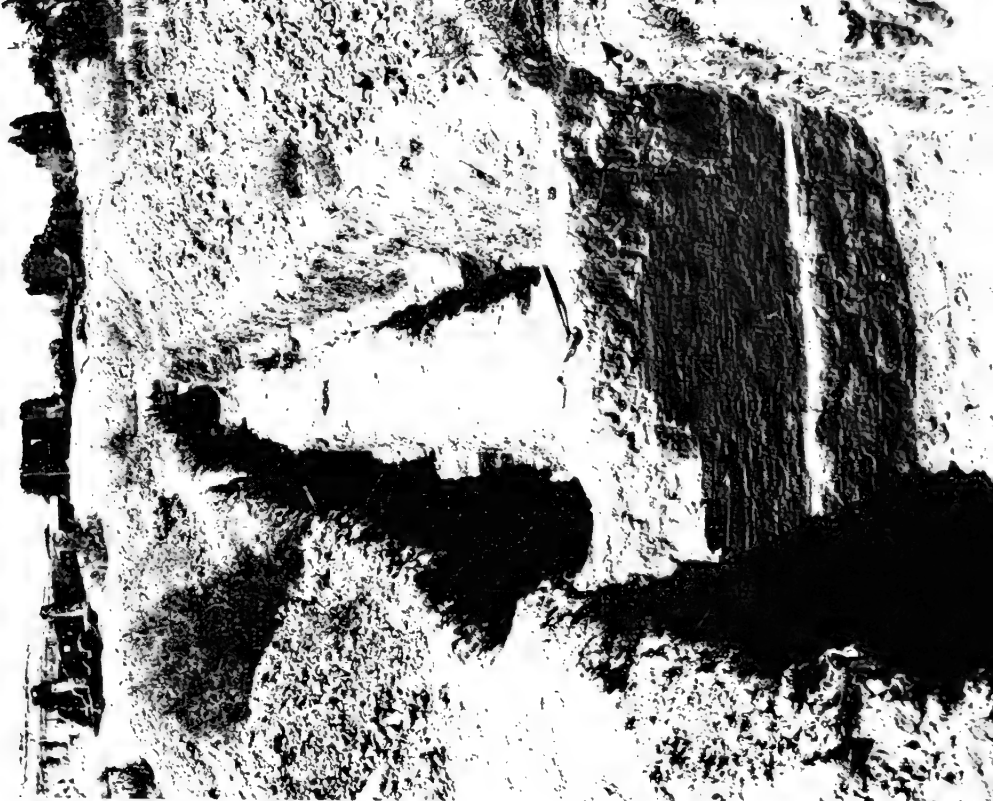
Lower: Paired foundations abut fourth-type masonry at Station 4, Northeast Complex, and curve thence south and west. (Photograph by Neil M. Judd, 1926.)

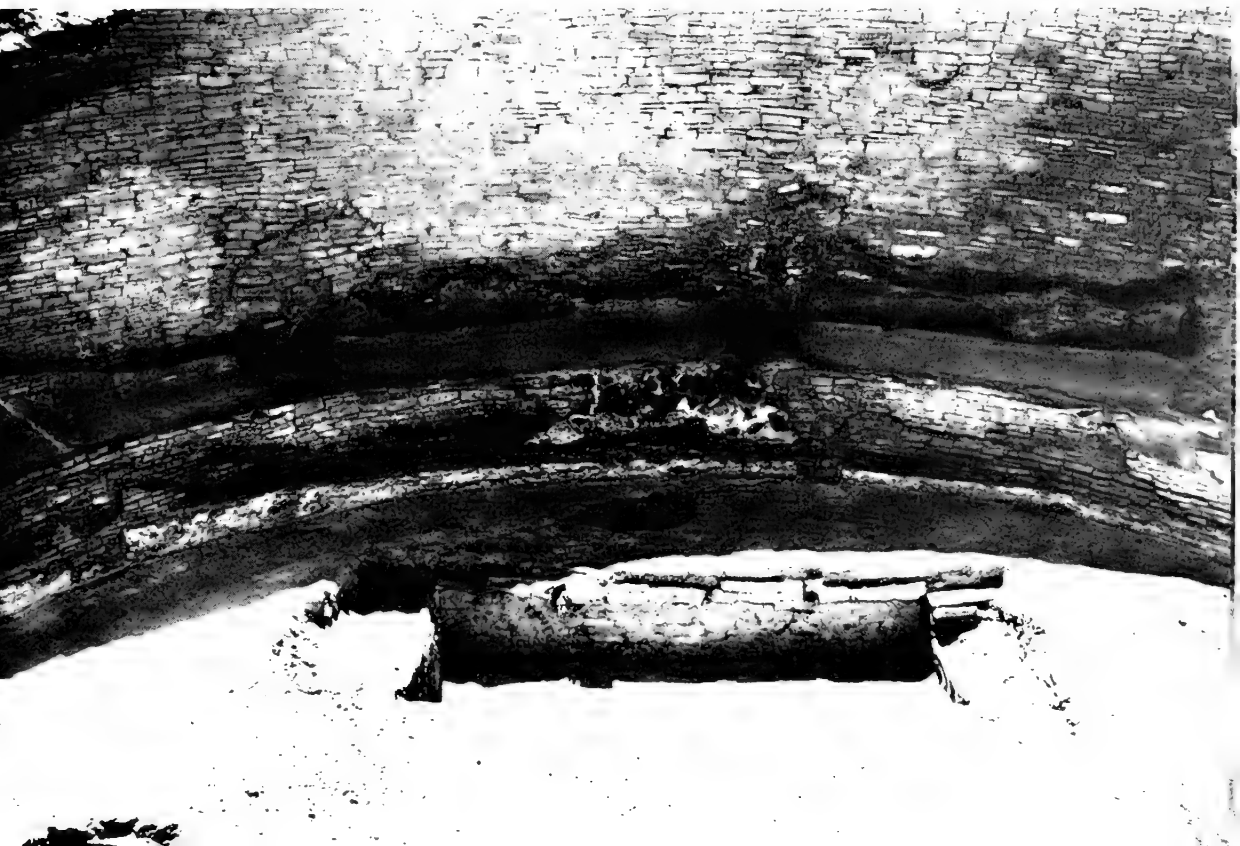
Lower: Squared pilaster timbers in Kiva D had been burned with their ceiling poles but the subfloor vault and ventilator survived.
(Photographs by O. C. Havens, 1921.)

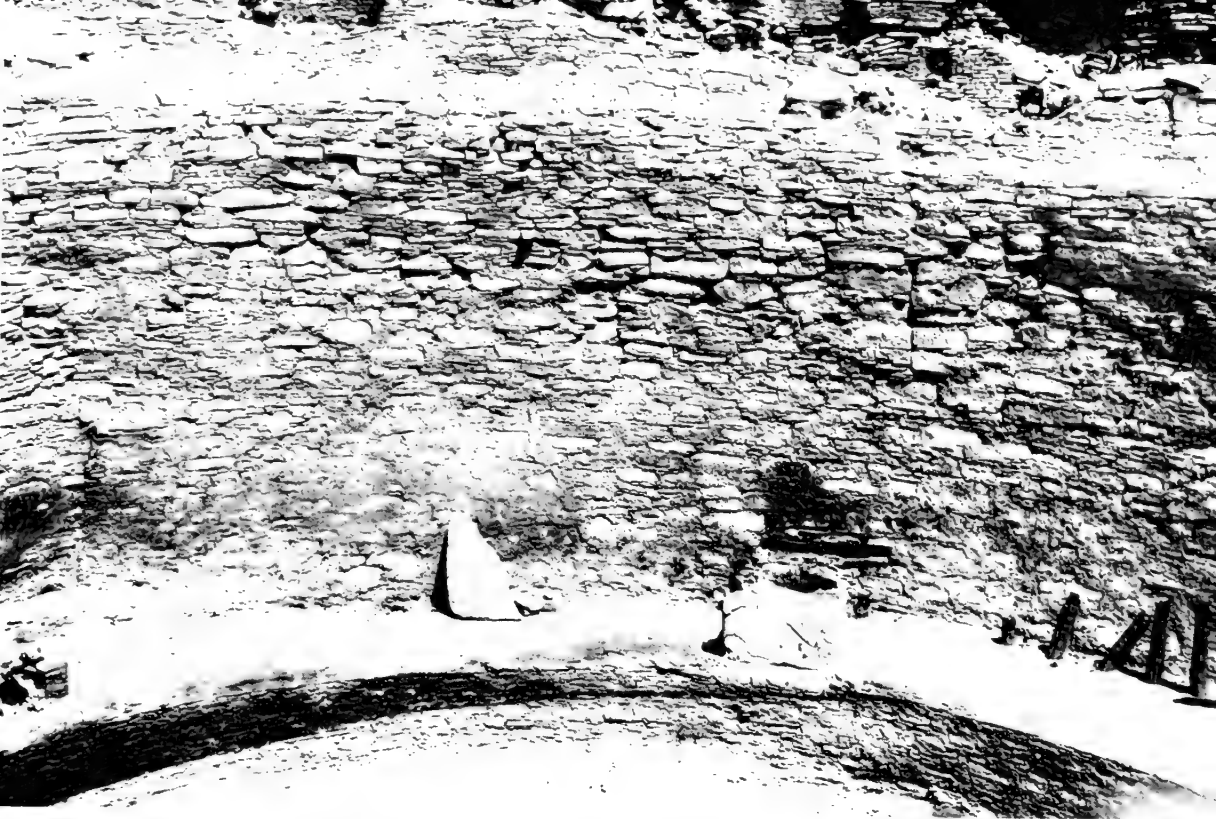
PLATE 69

Lower: Fireplace, ventilator, and south bench recess of Kiva R with Pilasters 1 to 3 beyond and
ceiling pole offset at upper left.
(Photograph by O. C. Havens, 1924.)

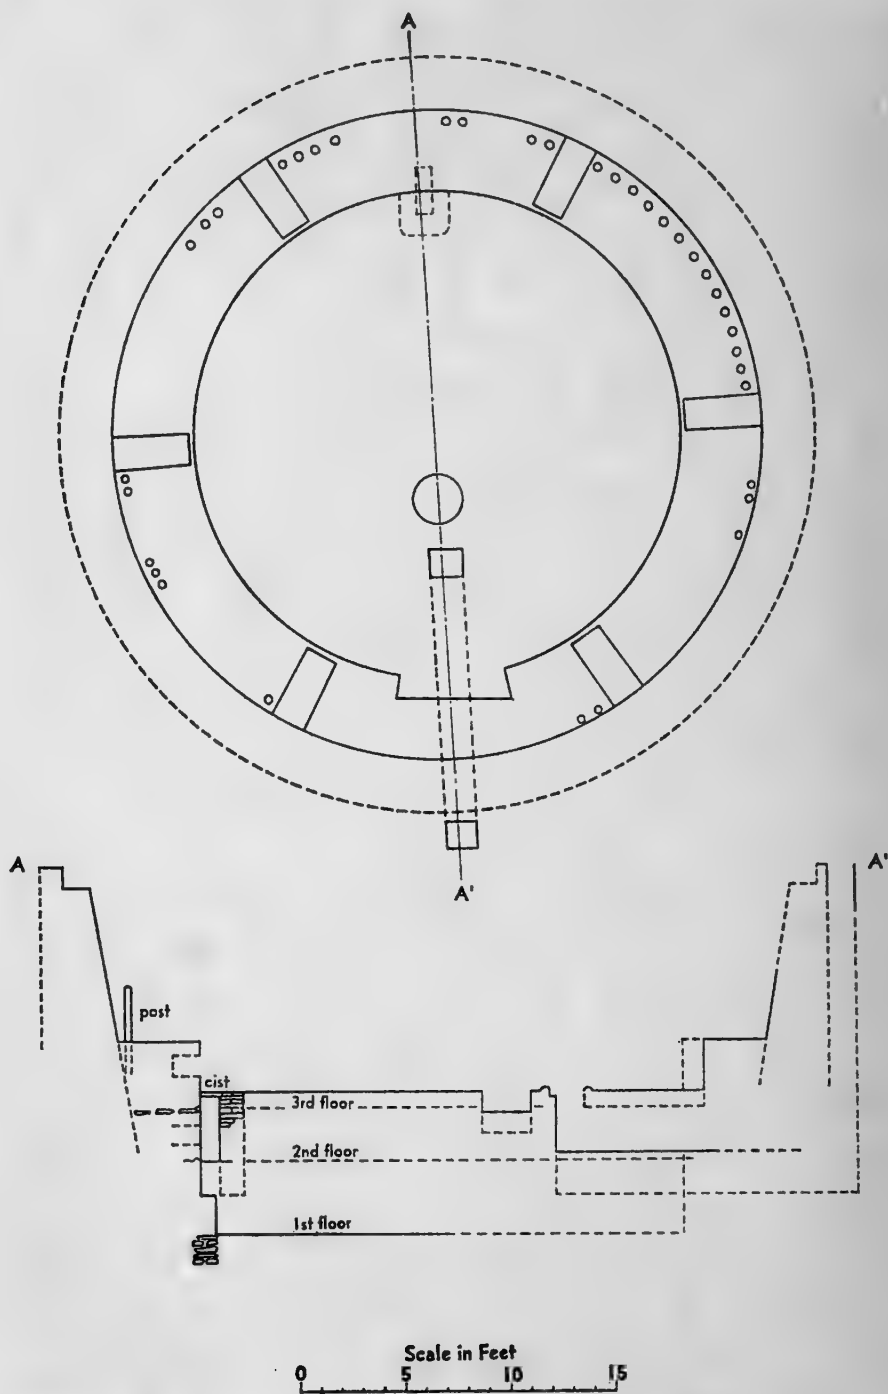
FIG. 22.—Kiva R with cross section, A-A', showing relationship of its predecessors.

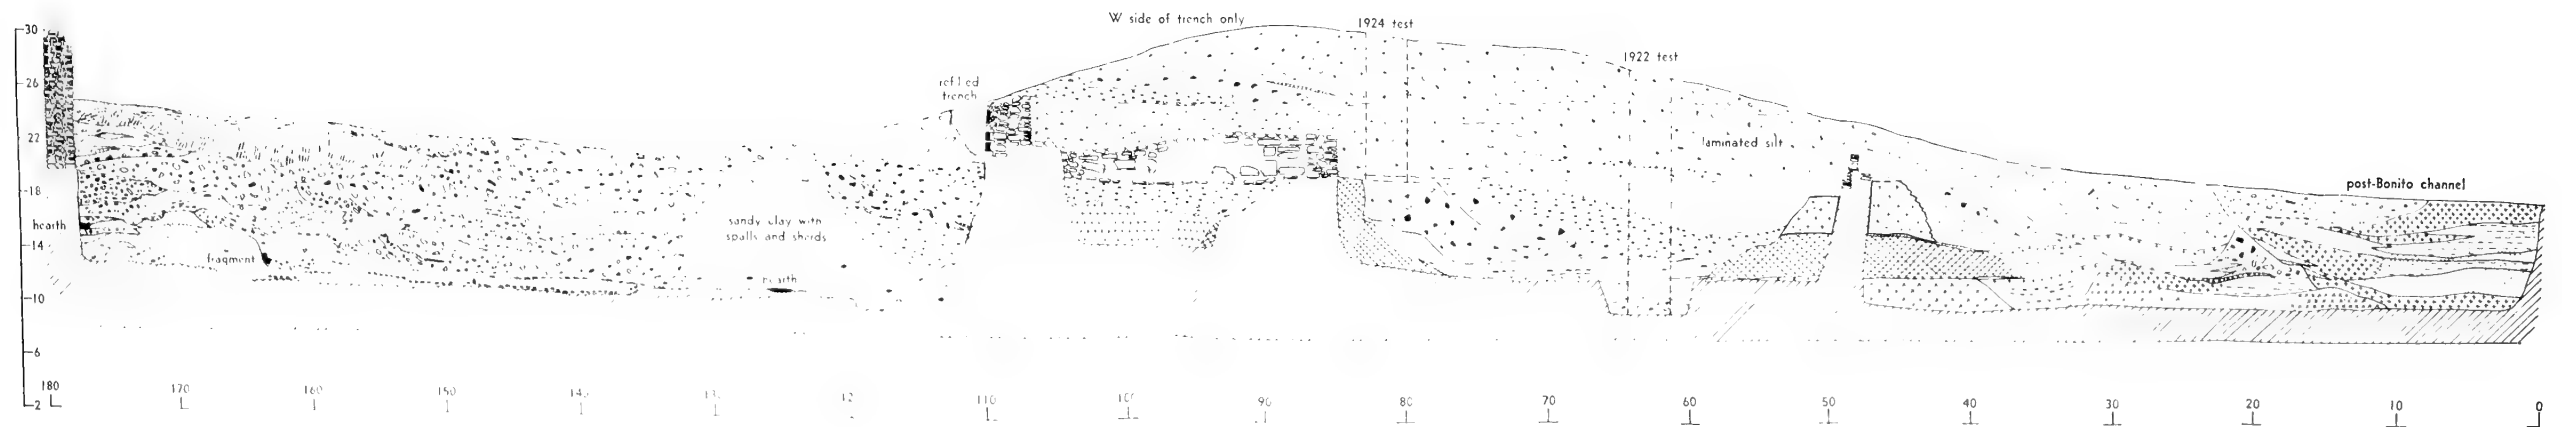
FIG. 24. The "Far East Trench" (upper); the "Middle Trench"; and the "East Mound Trench" from the post-Bonito channel to the foundations of Room 171.
